**COST Action TU1406**  
**Quality specifications for**  
**roadway bridges, standardization at a**  
**European level**

Extraction of Performance Indicators for  
UHPFRC strengthened bridge structures

This STSM deals with an actual case study, involving the rehabilitation of the former Buna Bridge, in Croatia, on the Zagreb-Sisak railway. This bridge is about 9 meters long and 0.9 m in height. The cross-section consists of two main girders made of hot rolled steel plates joined with rivets, and represents a beam structure that is typical of its construction period. The main girders are connected via horizontal and vertical grids for stiffening. Due to its handling weight of only 8.0 tons, this non-ballasted bridge offers a unique opportunity for transportation and subsequent experimentation in the laboratory. Structural Health Monitoring techniques are used in this project to obtain parameters that allow an identification of the actual condition of the structure in a first stage, and to compare the behavior of the bridge after the rehabilitation is performed. The latter includes a UHPFRC slab on top of the existing girders, connected via steel studs as in common composite sectio

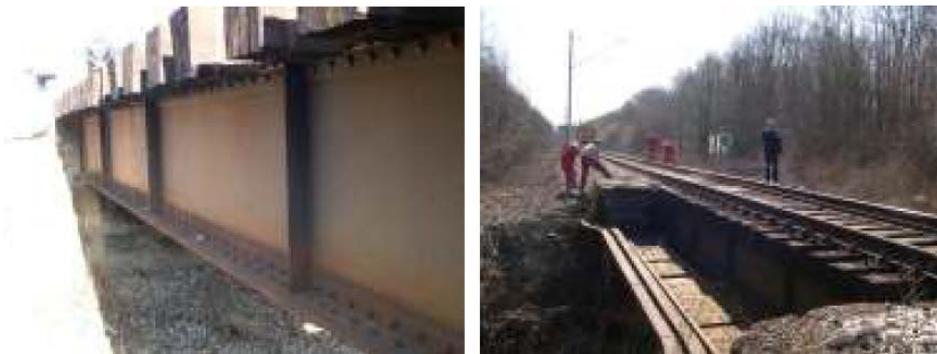
The bridge is about 9 m long and is conformed by two main girders, 0.9 m depth with an I shape. Both girders are distant 1.8 m one from the other and jointed at four sections by means of L profiles creating a truss, as well as a zig zag diagonal on the top. The lower zone of the structure remains unrestrained. It is particularly noticeable that wooden sleepers were applied directly on the girders, without any other structural element joining both elements.

Figure 1 Original location of Buna Bridge

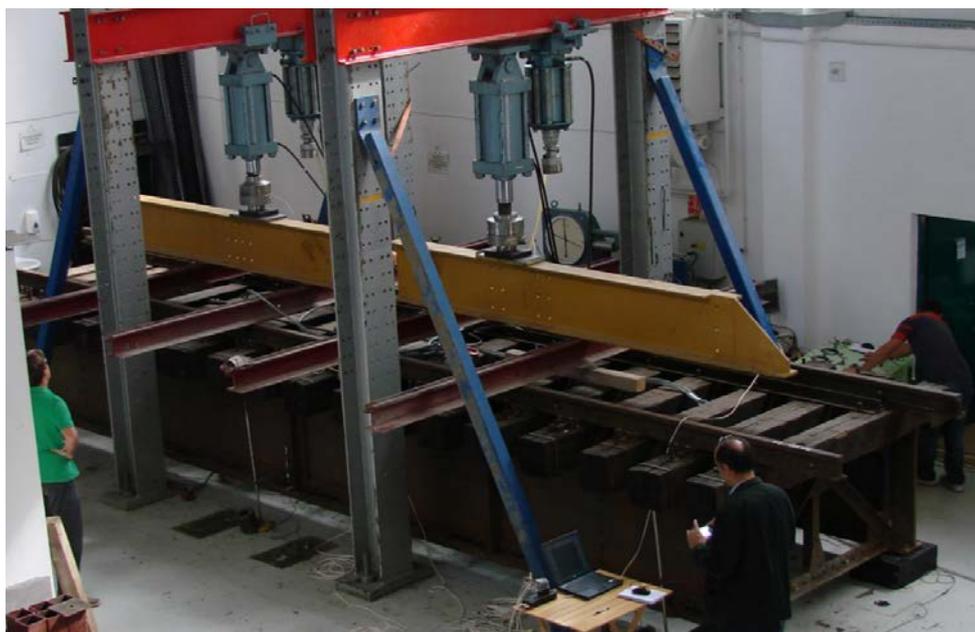
The first testing campaign was performed at IGH laboratory, in Croatia, aiming to determine maximum deflections and stress under a train load (Load model 71) based on the Eurocode EN 1991-2. The testing set up can be observed in Figure 3, and the results can be found in [5].

Figure 2. Buna Bridge testing at IGH facilities.

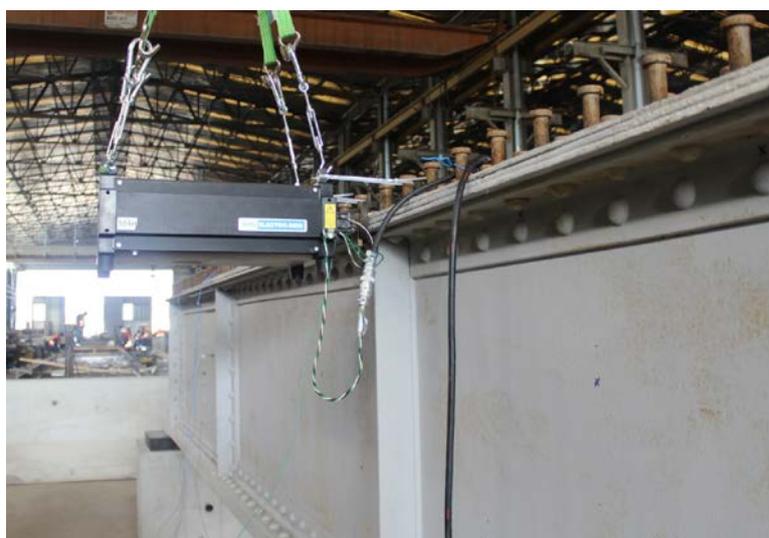
Two different dynamic test were performed on November 2016, carried out by the applicant and the department of Civil Engineering from Zagreb University. In the first one, the excitation was obtained by means of a shaker mounted both in vertical and transverse direction, as appreciated in Figure 4; whereas in the second one, ambient excitation was simulated by means of two hammers hitting randomly the structure. In both cases, the original bearings sustained the structure, although the rails and sleepers were not present. This decision was made due to the lack of fixation between the superstructure and the steel, which could have induced false modes on the analysis.

Figure 3. Shaker mounted in lateral direction for dynamic testing.
